Town of Arlington

FINAL REPORT

ADA Self-Evaluation (as basis for Transition Plan)

Prepared by
Institute for Human Centered Design
December 15, 2014

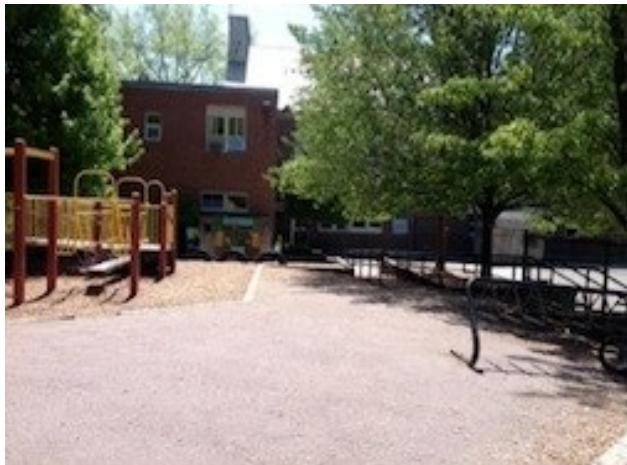
Photo 8

Walkways do not connect with play areas because the borders surrounding play areas is not level with either the loose fill in the play areas and the walkway hardtop. (Photo 8)

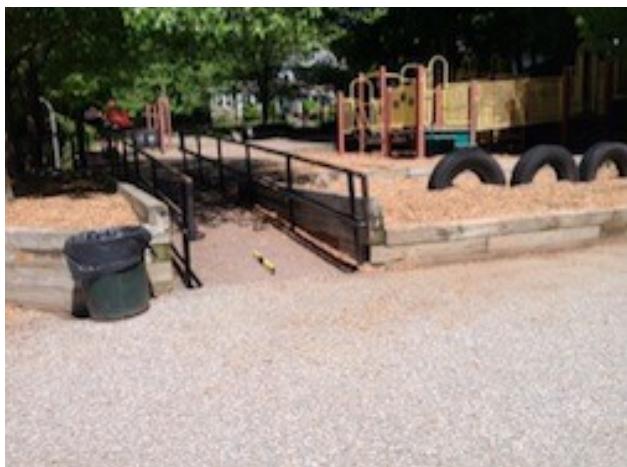
Photo 9

A straight ramp leading to the play areas from the school sidewalk provides a walkway that is accessible to all. This walkway connects via a hilly route to the court area below the upper playground area. (Photo 9)

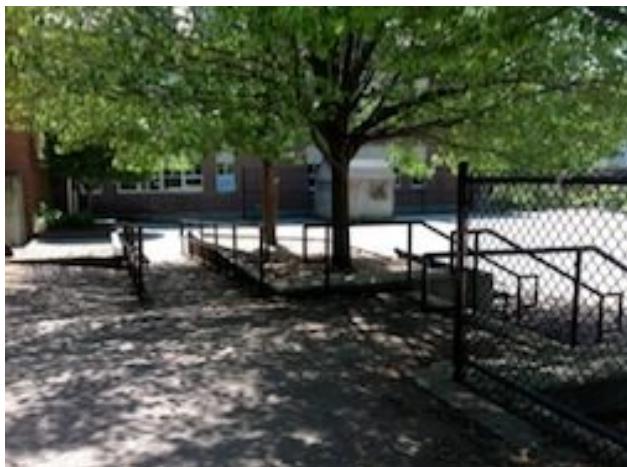
Photo 11

Stairways include accessible top handrails but lack accessible bottom handrails. (Photo 11)

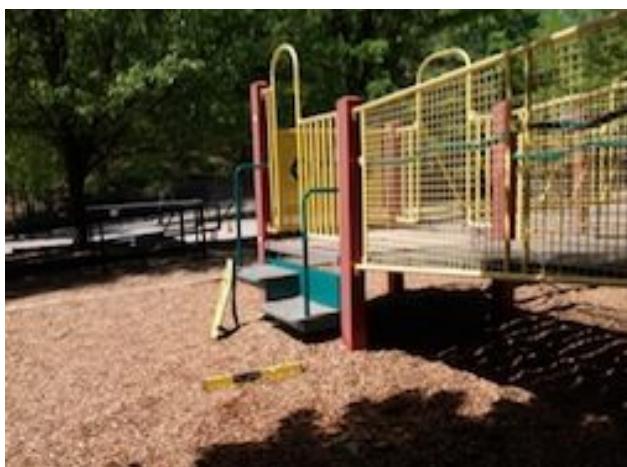
Photo 12

Although the play areas closer to the ramp include some accessible play structures, the loose fill ground surface does not hold accessible slopes. Cross slopes are over 5% near transfer steps, and at other entry/exit points within the play areas. (Photo 12)

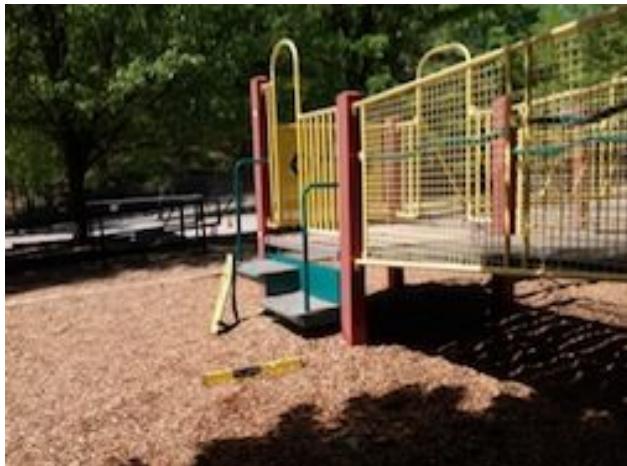
Photo 13

However, there is not an accessible (no-step) route to gain access to the accessible elevated ramp, so this is not an independently accessible feature. (Photo 13)

Although an effort was made to provide a level entry into the play area with the row of tires, the loose fill materials settle and the level entrance is not available. There can be a ramp or rubber entry provided from the surrounding walkway and an intersecting rubber tile route leading to and providing unrestricted circulation around the row of tires to provide interactive accessible play.

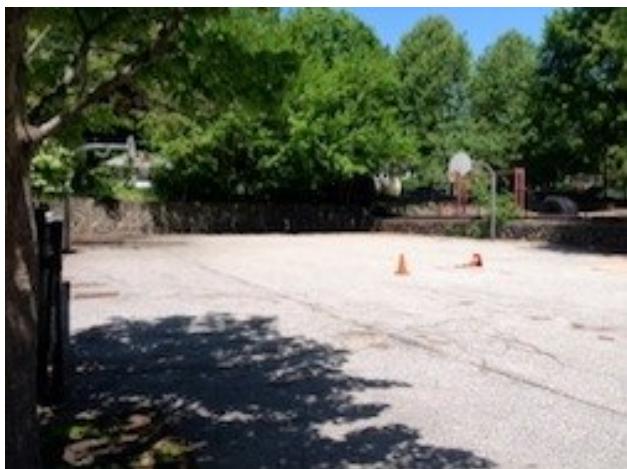
Photo 15

A full basketball court is provided at the entry gate from Irving St. This area also includes two accessible benches. (Photo 15)

The court in itself is an accessible program and area within the perimeter of site. However, the facility cannot be called accessible, because there are no accessible site arrival points to either facility entrance. (The nearby public transit routes from Pleasant @ Irving are not connected to any accessible public rights of ways, and the sidewalks leading to the Academy St. entrance have very excessive cross slopes.)

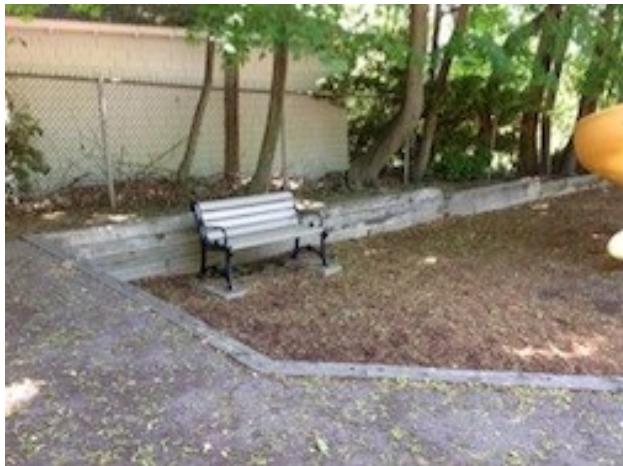
Photo 16

There is one bench at the playground area with a backrest and armrests. It is set into the recessed play area. This bench is inaccessible because it is not approached with an accessible route; and it is sitting on loose fill ground surface materials that are not holding an accessible cross slope. (Photo 16)

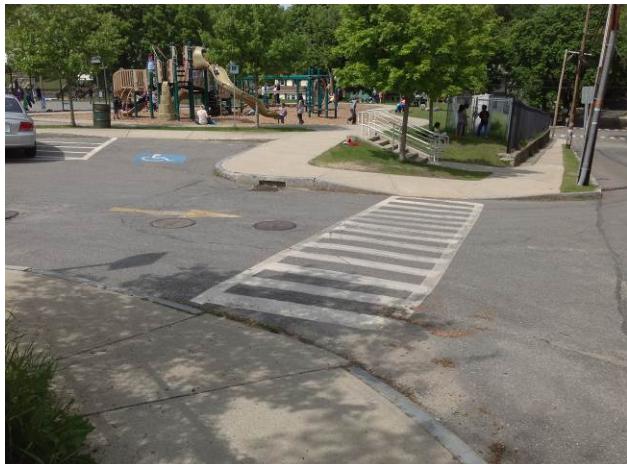
Photo 1

Sidewalks and curb ramps nearby Peirce School Park are in good condition. However, curb ramps provided on both ends of the crosswalk at the intersection of Newland Road and the driveway near the playground are not accessible because level top landings are not provided. (Photo1)

Repair both curb ramps at the intersection of Newland Road and the driveway near the playground (total of 2 curb ramps).

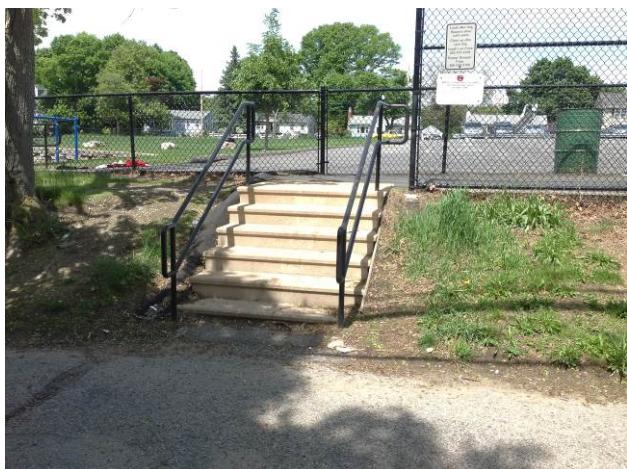
Photo 2

This facility has five points of entry: two stairways and a ramp along Pheasant Avenue and an at-grade access at the parking lot and a gate opening leading to the grassy field on Mountain Avenue. At the bottom of the stairway closest to the playground, the surface is in need of maintenance and is not slip-resistant. (Photo 2)

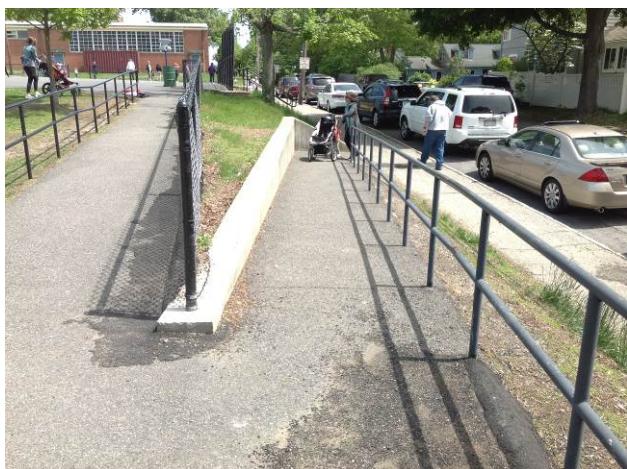
Photo 3

Twenty five feet west of the stairway, a ramp with missing railing on one side and a protective edge on the other side connects the sidewalk to the facility. Additionally, the surface at top of ramp is in need of maintenance. (Photo 3)

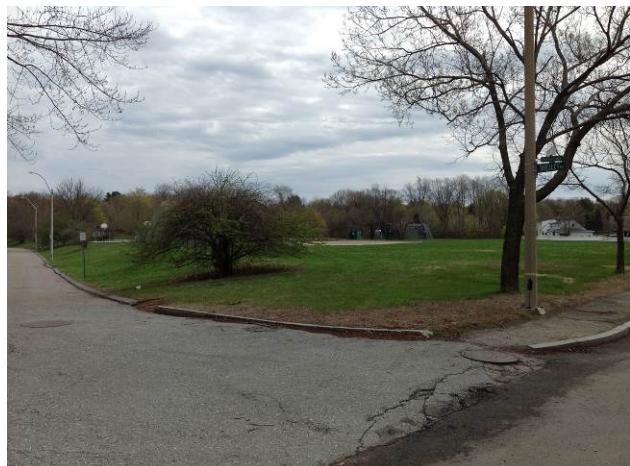
Photo 1

The sidewalk along Wadsworth Road is in poor condition. Not only are a few sections deteriorated but also the sidewalk has excessive cross slopes and sediments from adjacent areas that can make the ground surface slippery. Additionally, no sidewalk is offered along Shelley Road, except for the short section of sidewalk at the entry point near the playground. (Photos 1 and 3)

Repair sidewalk along Shelley Road (about 25 feet) and extend it to the intersection of Wadsworth Road in order to create an accessible route to the nearby public transit stop (about 500 feet).

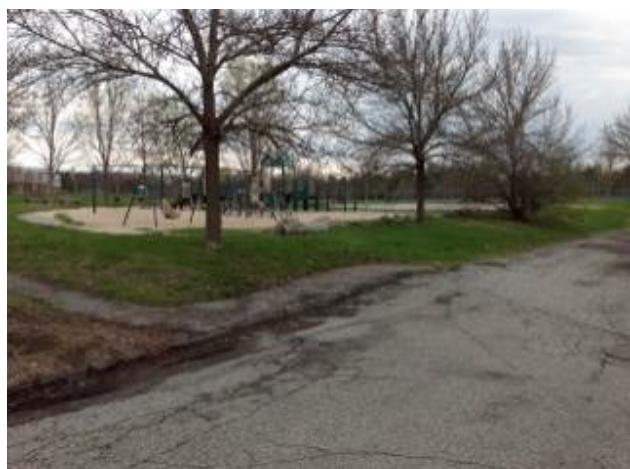
Photo 3

With the exception of the point of entry near the playground on Shelley Road, there are no other clear points of entry at this facility. This point of entry is in poor condition and lacks a curb ramp. (Photo 3)

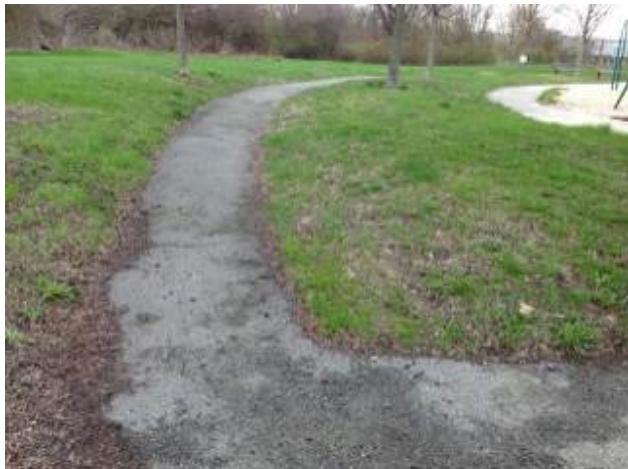
Photo 4

Although an asphalt walkway is provided between the point of entry at Shelley Road and certain features within this facility, it has excessively slopes near the street (11%) and deteriorated ground surfaces near the courts. (Photos 4 and 5)

Re-grade and repair the asphalt walkway so that it is free of tripping hazards and that running slopes are no greater than 5% and cross slopes are no greater than 2% (about 275 feet).

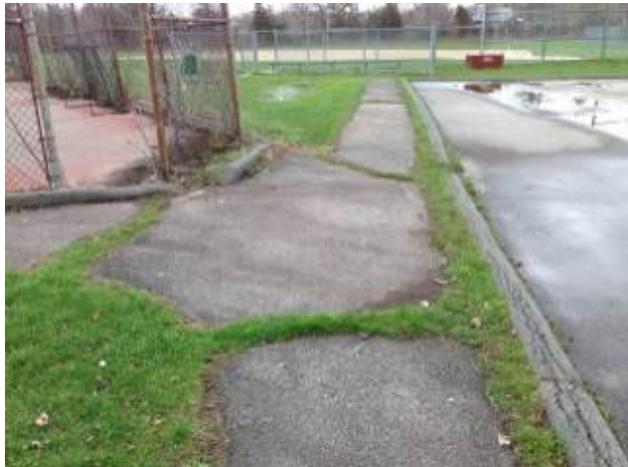
Photo 5

Because asphalt curbs are located along the perimeter of the tennis courts and the basketball court, no accessible route is provided to these courts. (Photos 5 and 6)

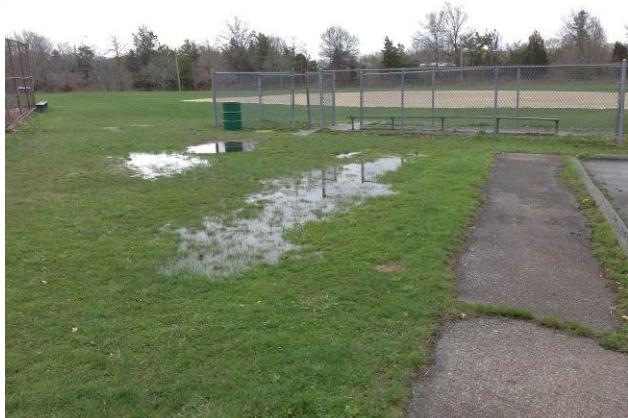
Photo 7

Additionally, the asphalt walkway does not extend beyond the basketball court and no accessible route is provided to the baseball field and batting cages on the South side of the facility. (Photos 7 and 8)

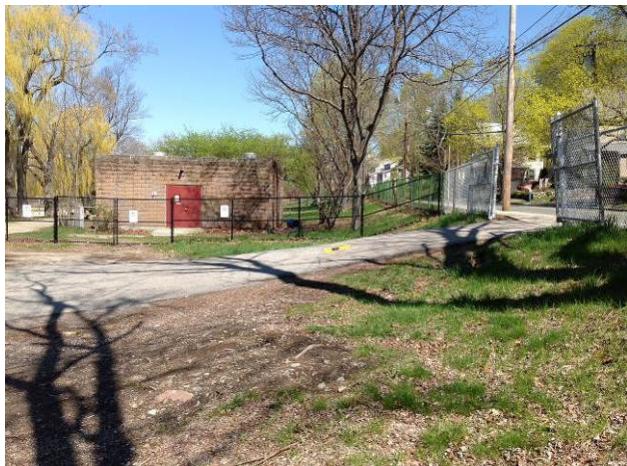
Photo 2

Along Lowell Street, both asphalt driveways that lead into this parking lot are also used for pedestrian access. The asphalt driveway closest to the beach is in poor condition and has excessive slopes (20%). (Photos 2 and 3)

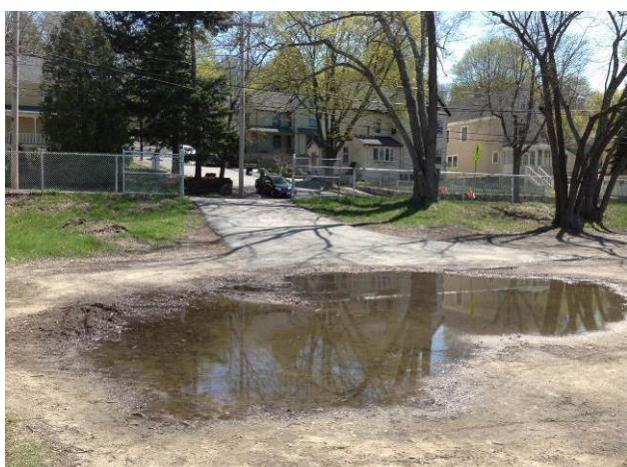
Photo 3

This facility has a large unpaved parking lot off of Lowell Street. Although two *ad hoc* spaces designated as accessible are provided near the gated entrance to the beach, they do not meet any of the minimum requirements for accessibility. (Photo 3)

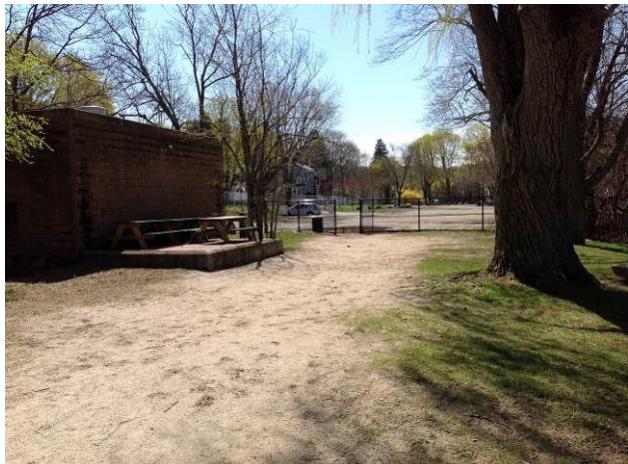
Photo 4

A sand path is provided along the entire facility. This path is not accessible because it is uneven and unstable, especially near benches and trees. Although a concrete walkway is provided near the water's edge, it is not connected to an accessible route. (Photos 4 and 5)

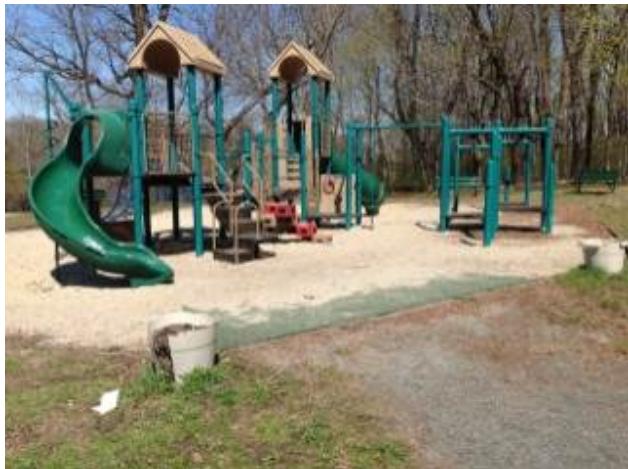
Photo 7

One large sandy area contains three separate zones of play structures. Although an accessible route is provided to the large play structure, the transition between stone path and rubber surface is in poor condition. (Photo 7)

Repair the transition between stone path and rubber surface at the large play structure and install an accessible walkway between points of entry and the swingset and the small play structure. The accessible route to these play areas can adjoin the new accessible walkway through the facility.

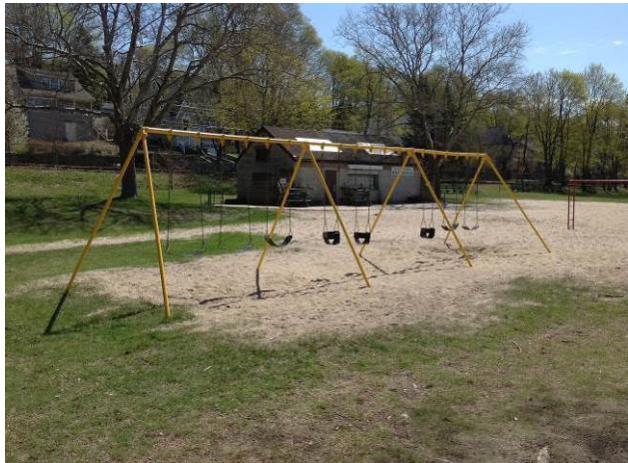
Photo 8

No accessible route is provided to the swingset and the small play structure. (Photos 8 and 9)

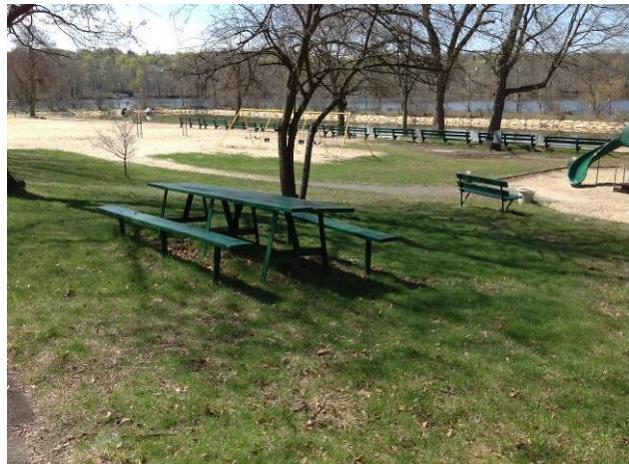
Photo 10

One picnic table is provided near the playground; however, it is not accessible because it does not provide the required knee clearance for people using wheeled mobility devices and is not located along an accessible route. (Photo 10, next page)

Replace the picnic table near the playground with an ADA-compliant amenity and extend the asphalt walkway to it (about 75 feet).

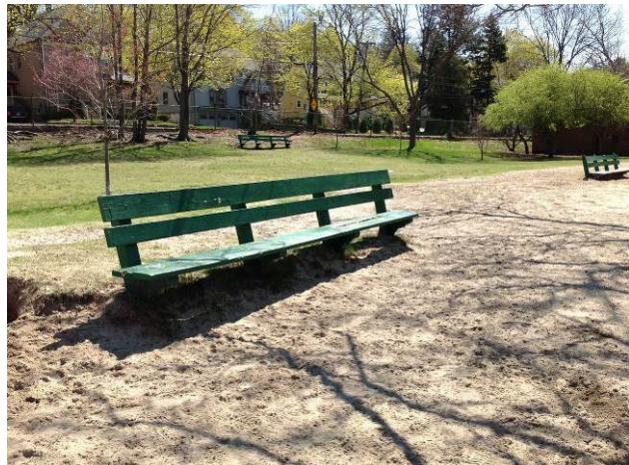
Photo 11

Several benches are provided through this facility. They can be found along the sand path and trees, within the grassy knoll near the fence on Lowell Street, within the playground, and near the water's edge. The benches are not accessible because they do not adjoin an accessible route. (Photo 11, next page)

Although not a requirement under the ADA, consider providing at least 50% with armrests, as benches are replaced (total of 10 benches).

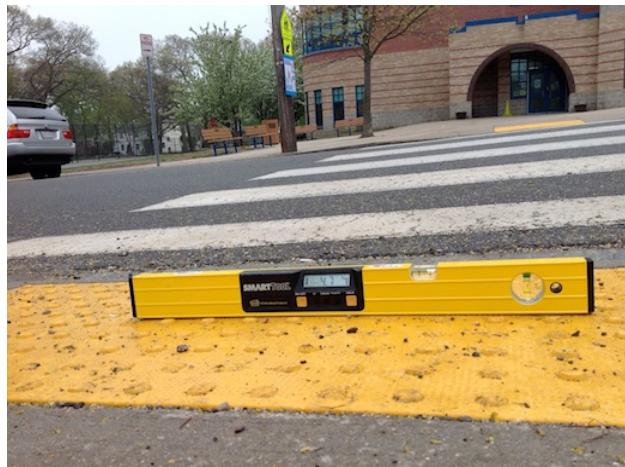
Photo 2

New curb ramps with tactile strips are provided at crosswalk between school entrance and 1 park entrance. Both curb ramps have noncompliant cross slopes and excessive level changes at bottom.
(Photo 2)

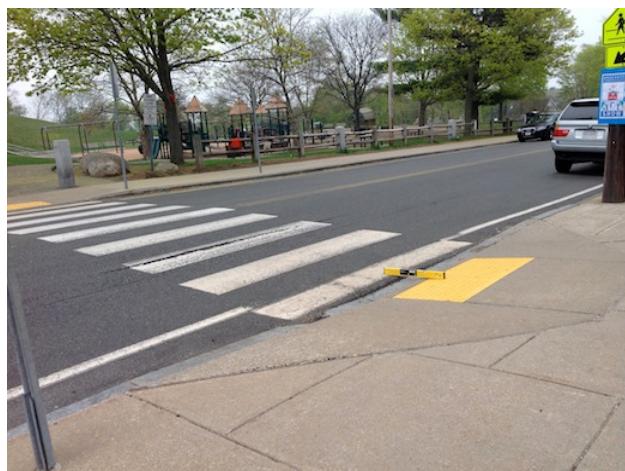
Photo 3

The curb ramp on school side of crosswalk also has a noncompliant run slope and an excessive vertical depression at the gutter to ramp transition, leading to water and ice accumulation issues. (Photo 3)

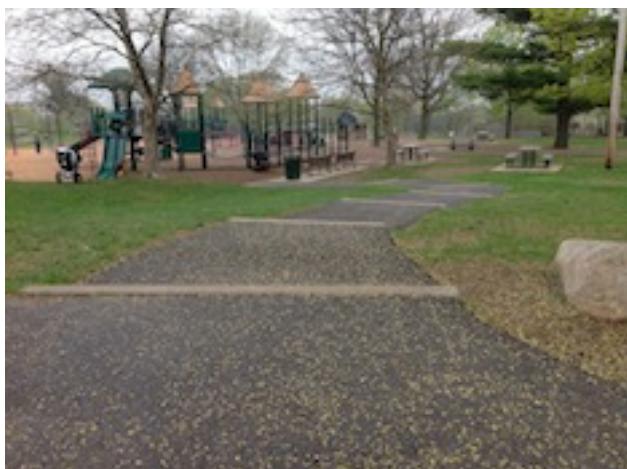
Photo 6

The only interior connection between these 2 entry walkways is an inaccessible wide tiered stairs route with *no* handrails.

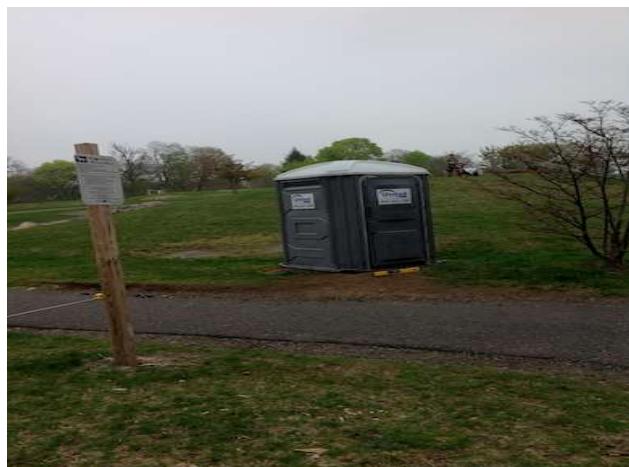
Photo 8

The walkway extending from the school crosswalk entrance provides an at-grade entrance and access to the Long Hill Slide/staircase top and the Boston Skyline Viewing Oval. This route has some cross and run slope issues that can be mitigated with small wall or handrail supports. This walkway does not connect to the border of field sports activities, the 2 sides of the court, the benches on Baseball Hill, or the portable toilet entrance. (Photo 8)

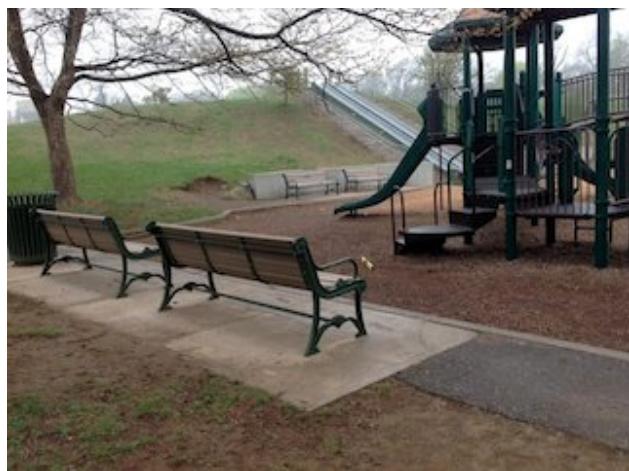
Photo 9

Although the walkway from the entrance west of the school crosswalk leads to the play areas and benches, it does not provide an accessible connection because of level changes and lack of clear width. (Photo 9)

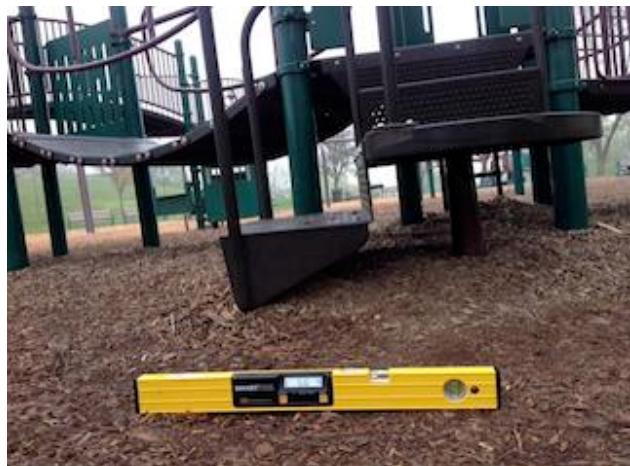
Photo 10

Loose-fill surface materials require frequent maintenance to ensure accessibility in all seasons. These play areas do not currently offer accessible circulation routes because the ground surface materials have excessive cross slopes, depressions, and protrusions near and within ground play elements and transfer stations. (Photo 10)

- a. If only loose fill ground surface materials are used, implement a high-frequency maintenance program to ensure accessibility of ground surface materials through all seasons.
- b. If ground surface materials will be replaced: consider adding unitary surface materials within the playground areas to provide accessible routes and clear ground spaces to all entry/exit points of ground play elements, including swingsets, play structure transfer station, and ground play elements.

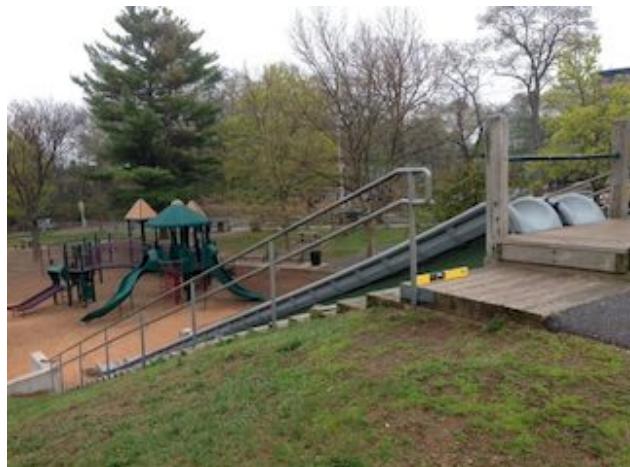
Photo 11

The recessed playground area is the exit point for the Long Hill slides and accommodates 2 play areas that are age-appropriate. There is no accessible connecting route between the bottom and the top of the slide. (Photo 11)

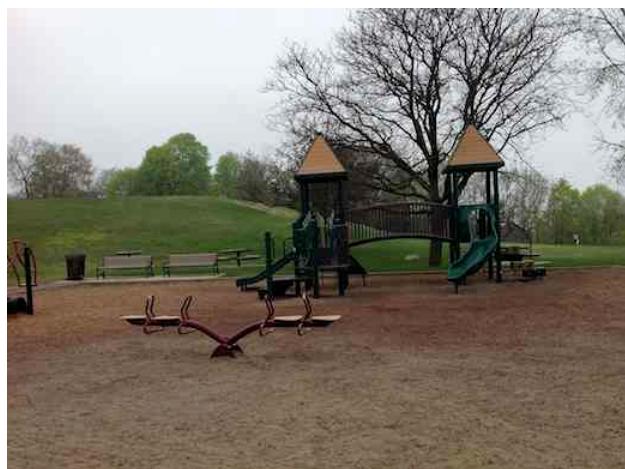
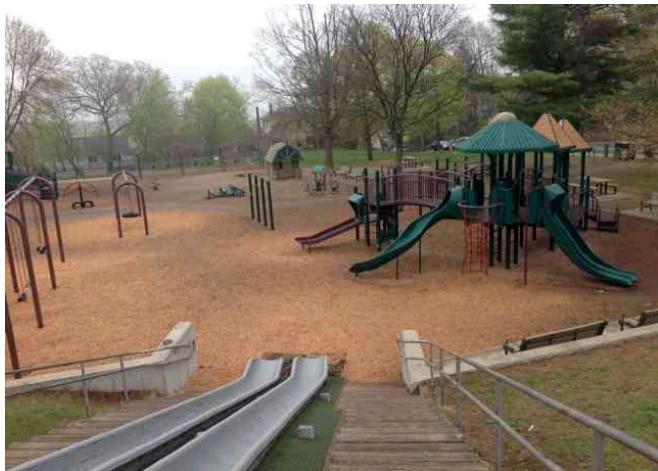
Photo 12

The play structure for younger children has an exceedingly steep ramp that does not provide accessible use of elevated play components. Although there are a unique variety of free-standing ground play elements, including 2 wooden cars, 1 small cabin, a See-Saw, Multi-Pondo, and a sandbox; and, the play structure also offers 3 types of ground play elements, these elements are not accessible because the ground surface materials are not accessible and there are no accessible entry points into play areas. (Photo 12)

The composite play structure for older children does not include an accessible elevated route. The transfer steps do not lead to at least 51% of different types of elevated play features.

There are 8-13 inaccessible play features for older children, including the Long Slide, which is not connected to an accessible route from bottom to top. There are not a proportionate number of accessible ground or elevated play elements for children with disabilities, age 5 and older. (Photo 12)

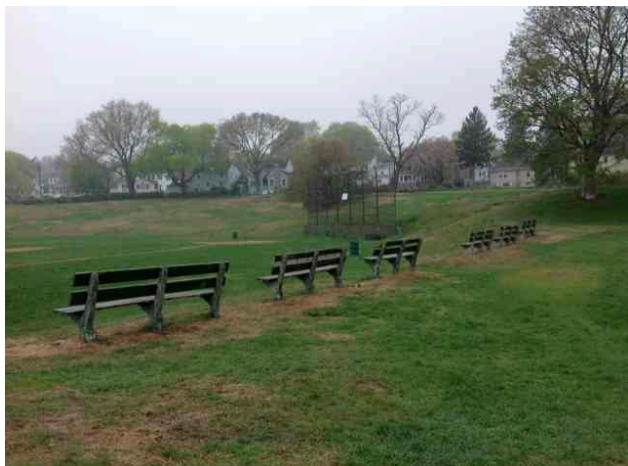
Photo 14

The soccer and ball fields are not located along an accessible route. Run slopes near benches indicate that an accessible route with handrails is feasible. (Photo 14)

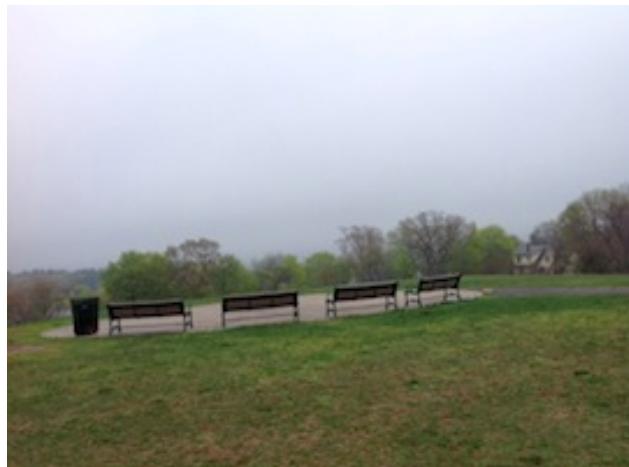
Photo 16

The Viewing Oval is connected to one interior walkway; and there is a level, firm and smooth clear space available to be used for integrated wheelchair seating. (Photo 16)

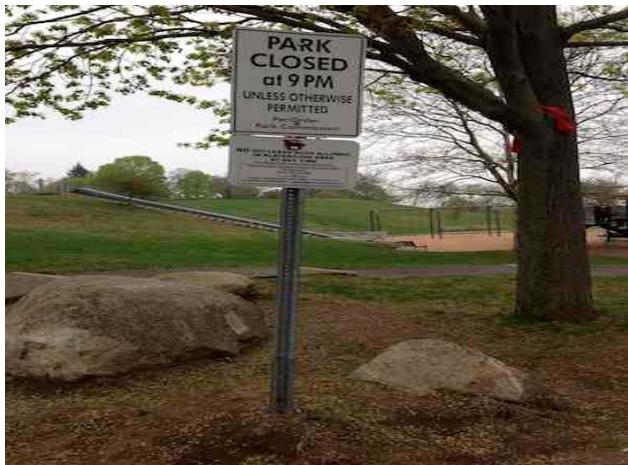
Photo 19

Signage denoting Dog Walk Hours and rules are posted too high proportionate to the approach and viewing distance provided along the trails. (Photo 19)

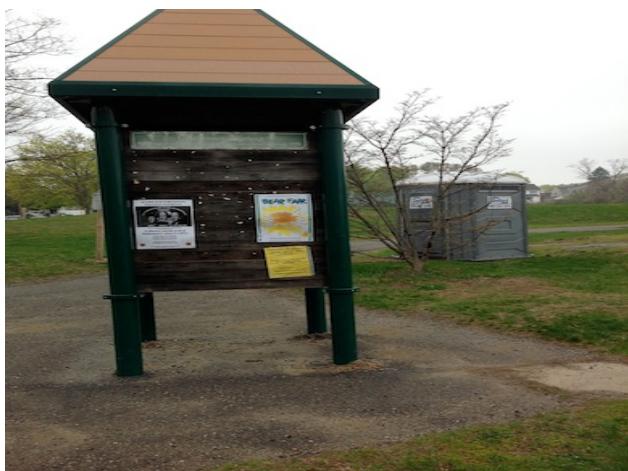
Photo 20

The information kiosk/bulletin board at the crosswalk entry point includes health information about Lyme disease that is mounted above 60 inches from the ground and cannot be read because the font is too small. (Photo 20)

Kiosk: Review signage requirements and reinstall as necessary.

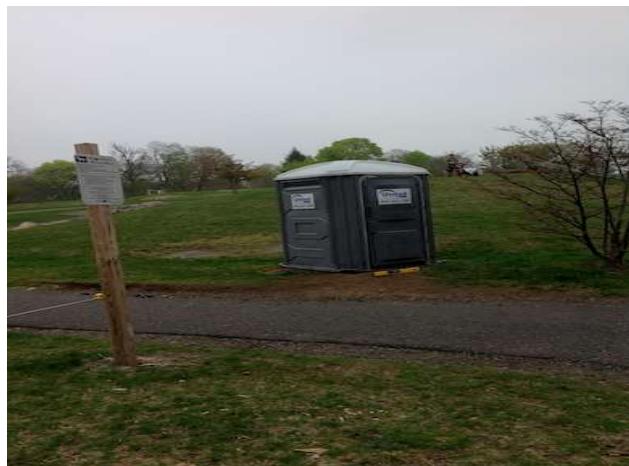
Photo 21

Rental of portable toilets began in 2012. This is an accessible portable bathroom; however, it is not located along an accessible route. The route from the walkway to the door is dirt mixed with gravel and is steep, not slip-free, not firm and not level. (Photo 21)

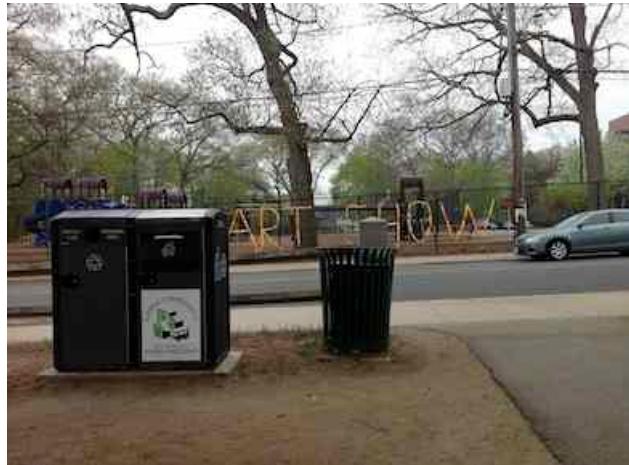
Photo 22

The recycling compactor is not located along an accessible route and is located on a platform, which does not provide accessible reach ranges or accessible clear space for forward and parallel approach. (Photo 22)

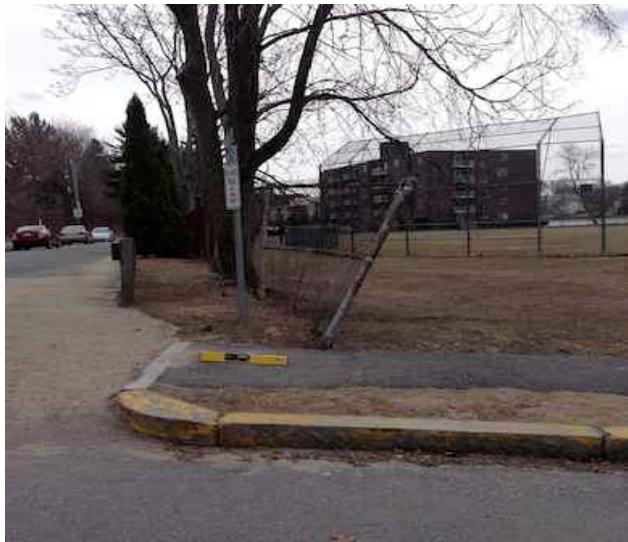
Photo 2

There is no accessible approach to the facility entrance because of missing curb ramps and uneven sidewalks. A curb ramp is missing at the southwest corner intersection, Hamilton St. and Linwood St. (Photo 2)

Construct an accessible pedestrian route from Mass Ave to Linwood Circle. Add curb ramps where missing.

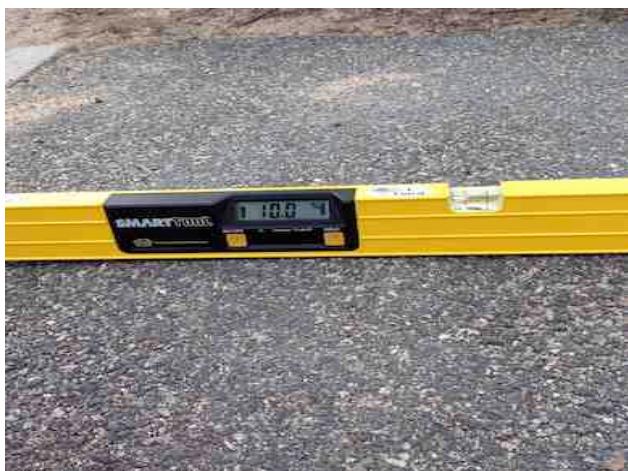
Photo 3

The sidewalk adjoining facility and around rotary has excessive slopes, and needs maintenance. (Photo 3)

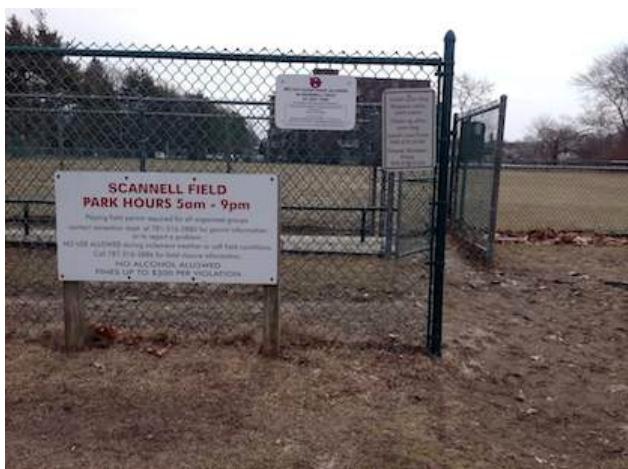
Photo 5

There are gated points of entry around the fenced-in field and to the home and away-team dugouts. No entry points are connected to an accessible route. There is no firm, level and slip-free walkway to the fence limits, field, dugout areas or bleachers. (Photo 5)

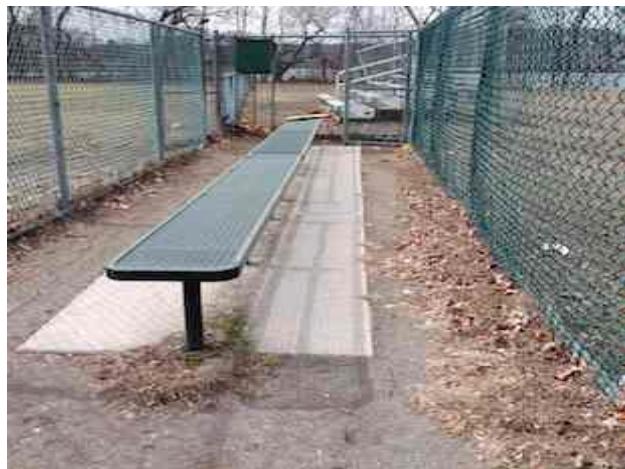
Photo 9

There are no accessible routes within the team seating areas. There is no accessible integrated wheelchair seating location within dugouts. (Photo 9)

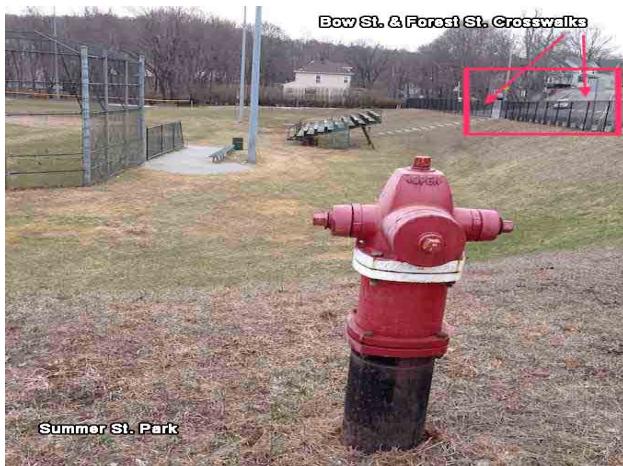
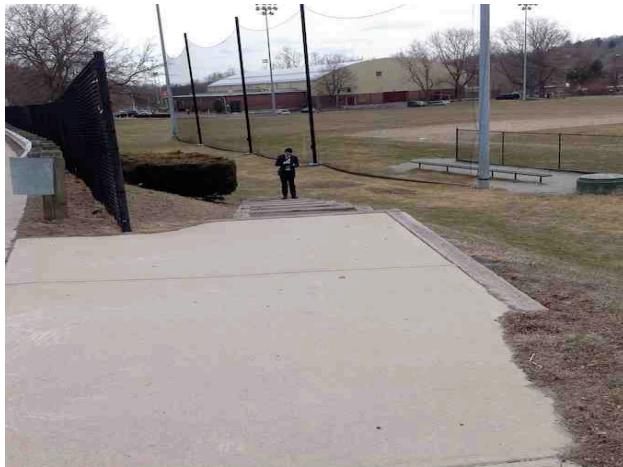
Summer St. Park has two points of entry at Forest St. and both entries have staircases and no accessible points of entry. The staircases lack handrails on either side and do not adjoin an accessible route from entry to boundary of sports playing fields, team seating area and bleacher areas. (See Photos 1 & 2)

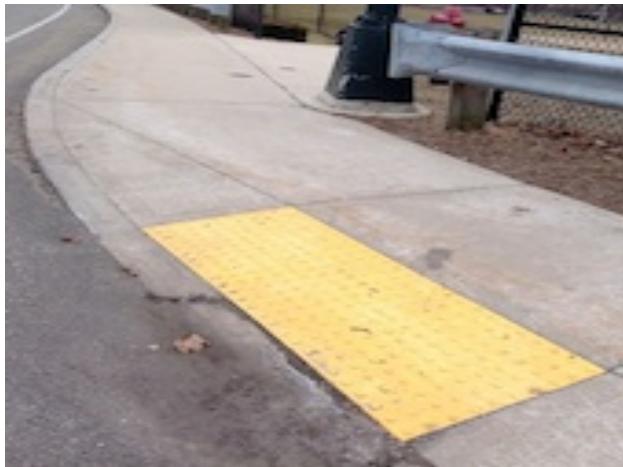
Photo 3

- Excessive cross slopes at sidewalk panels adjacent to three Accessible Pedestrian Signal controls (APS);
- Curb ramps are not oriented into crosswalks;
- Excessive cross slopes in sidewalk routes between new curb ramps;
- Sidewalk joints over 1/2 inch width; and
- Curb ramp transitions at gutter are in disrepair. (Photo 3)

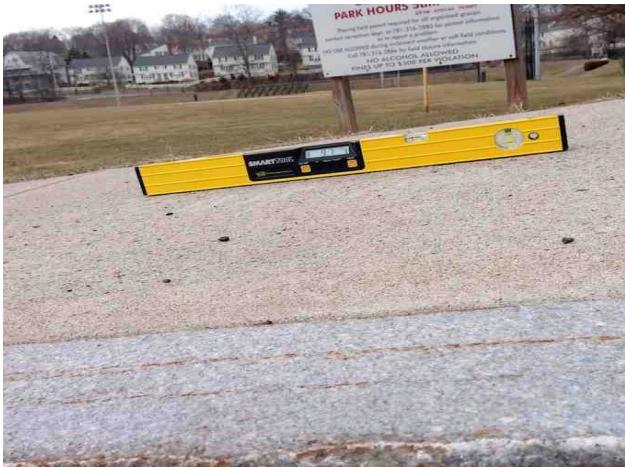
Photo 5

Due to natural terrain issues, this sidewalk needs to be ramped, with handrails. Cross slopes can be mitigated to compliance; run slopes will exceed 5%. (Photo 5)

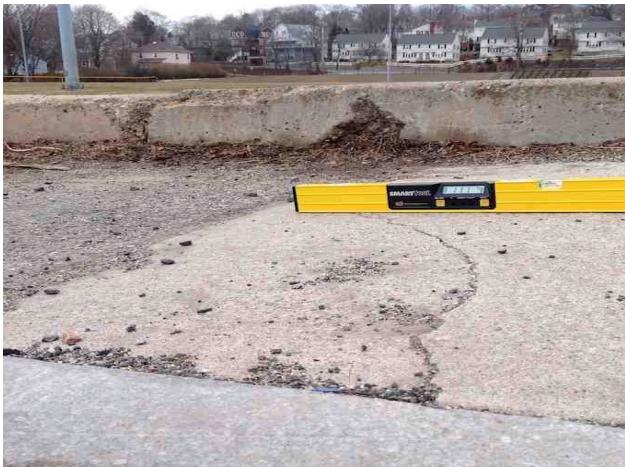
Photo 6

The line of work for this sidewalk ends prior to the Summer St. point of entry and the stone dust path does not provide an accessible site arrival point into the Park. (Photo 6)

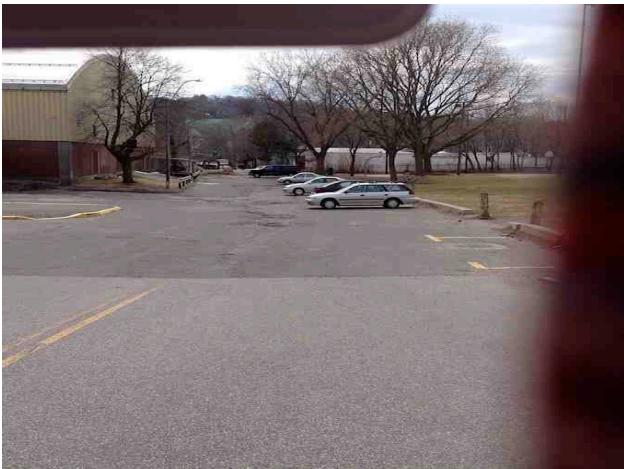
Photo 8

Beyond this entry point are approximately 12 additional parking spaces adjacent to Summer Street Park that are not connected by a pedestrian accessible route to Summer Street Park or to any of the facility entry points and amenities within the Sports Complex, including the perimeter sidewalk around the Ed Burns Arena. There is no designated van-accessible or accessible parking space along this group of parking spaces. There is no pedestrian accessible crossing route between this parking area and other pedestrian routes, bikeway connections, and outdoor areas within the Sports complex. (Photo 8)

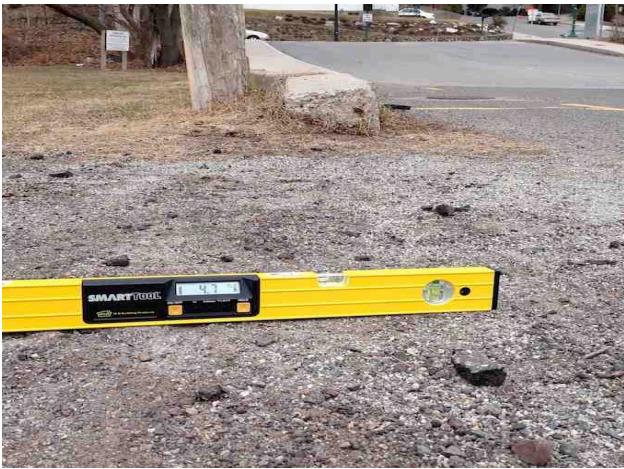
Photo 9

Along Ryder Street, marked point of entry is an eroding stone dust path. This path has excessive cross slopes and does not connect via an accessible route to any other facility program areas. (Photo 9)

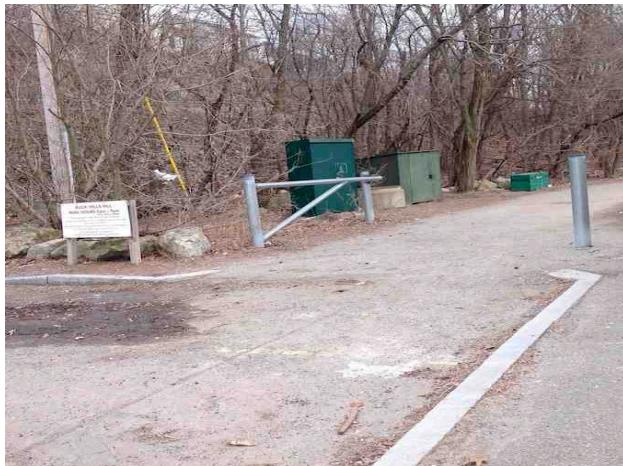
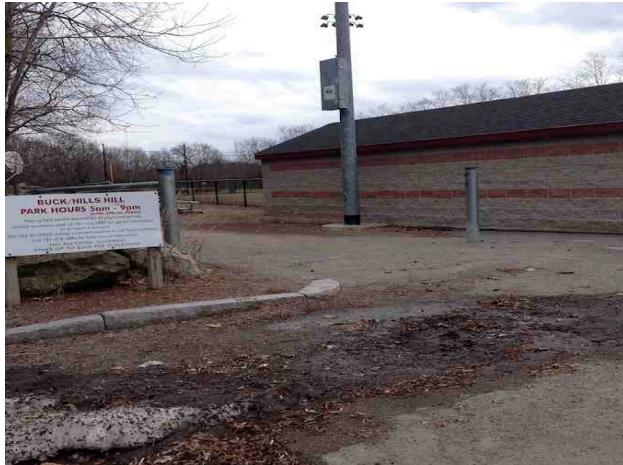
This point of entry is used as a service entrance for maintenance and needs to provide a smooth, level, firm, slip free route without water and other weather event accumulation. There are currently no accessible route components provided at this point of entry. (Photos 19, 20)

1. Relocate point of entry about 5 feet SW if needed to accommodate a straight crosswalk between Summer St. Park and reciprocal curb ramp at Ed Burns Arena facility perimeter sidewalk (Ryder St.)
2. Ensure that this point of entry is at least 36 inches width, ground surface is paved, level, with cross slopes not exceeding 2.08%; and that this point of entry is connected to new interior walkway within facility.
3. Extend interior walkway from play area to point of entry. (about 150 feet)

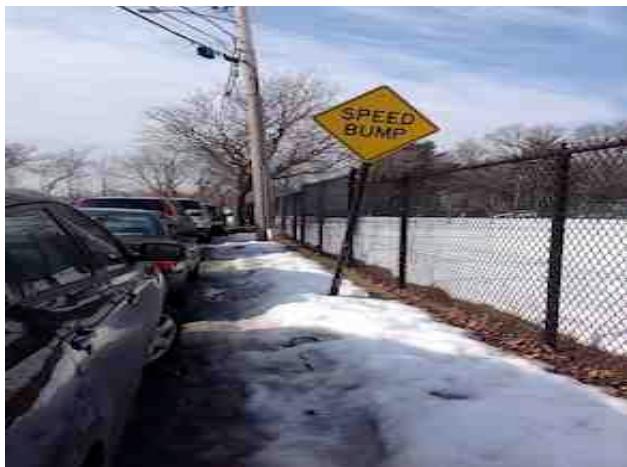
Photo 3

South and southeast facility entry points are not located along any accessible routes, and sidewalks are incomplete or missing. (Photo 3)

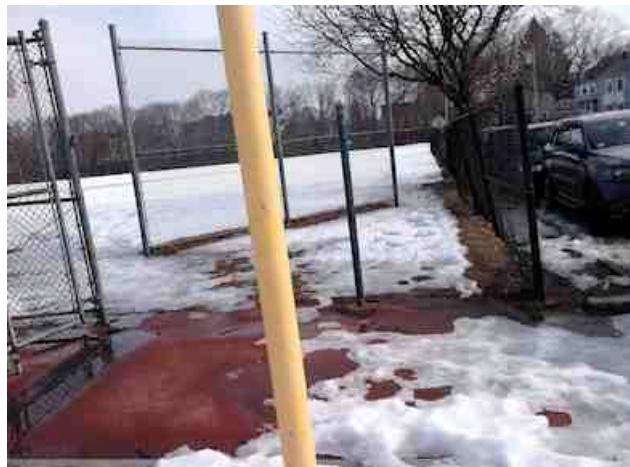
Photo 8

Two public gated entry points from public streets to facility are not along an accessible route and do not provide smooth, firm, level and slip-free ground surfaces. West Tennis Court gate does not open to at least 32 inches. Pond Lane gate approach is obstructed by on-street parking, lack of sidewalk route, and a paved entryway that is in disrepair with excessive cross slopes and tripping hazards. Gates require smooth surface or kickplate on push side. (Photo 8)

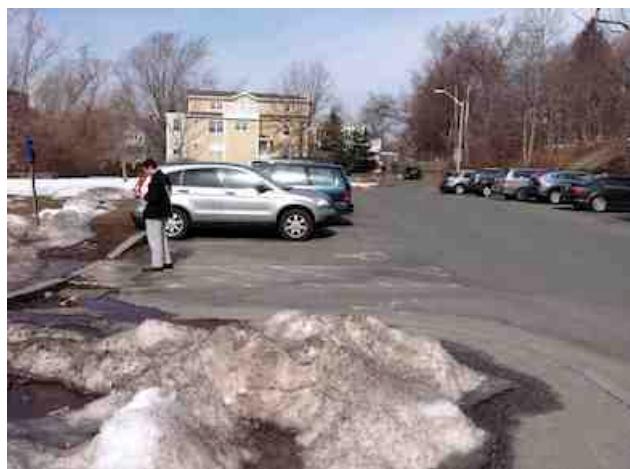
Photo 3

A curb ramp is provided at the North Beach Parking Lot in front of the 2 HP-designated spaces that share an access aisle. This inaccessible element has excessive cross slopes, excessive gaps and excessive level changes at gutter-to-ramp and ramp-to-sidewalk transitions. It lacks clear turning space and leads to a sidewalk with excessive slopes. (Photo 3)

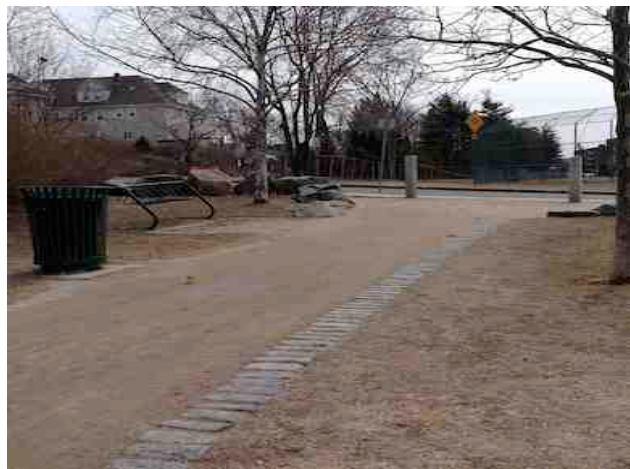
Photo 12

Point of entry to the South Beach Shoreline path is not accessible because the lengthwise cobblestone border at the head of the trail, similar to the head of the path from the North Beach, does not provide a level, smooth and slip-free transition between the Linwood Circle sidewalks and the graded shoreline path. This continuous edging also acts as a barrier to access the tables, benches, some trash receptacles and other viewing amenities along the length of the shoreline path. (Photo 12)

South Beach At head of Shoreline path at bollards gate, design and install solution to uneven surface caused by embedded cobblestones at point of entry.

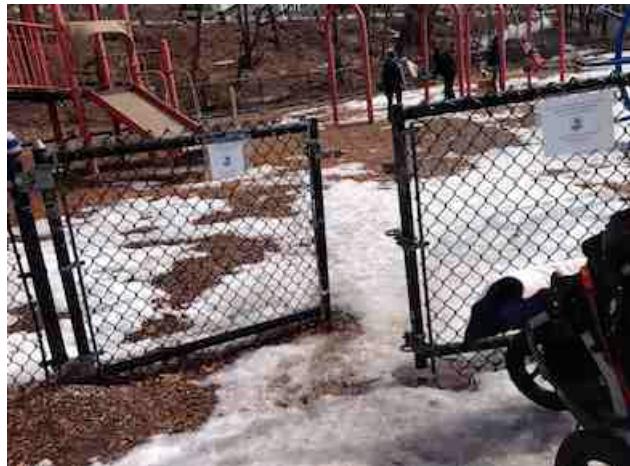
Photo 13

The Playground gate entrance, at North Beach, has an uneven, unstable ground surface, which accumulates water. There is inadequate clearance width at the opening because the ground surface includes uneven areas that hinder a 90-degree swing of the gate. Gate requires a smooth surface or kickplate on push side (2010 requirement). (Photo 13)

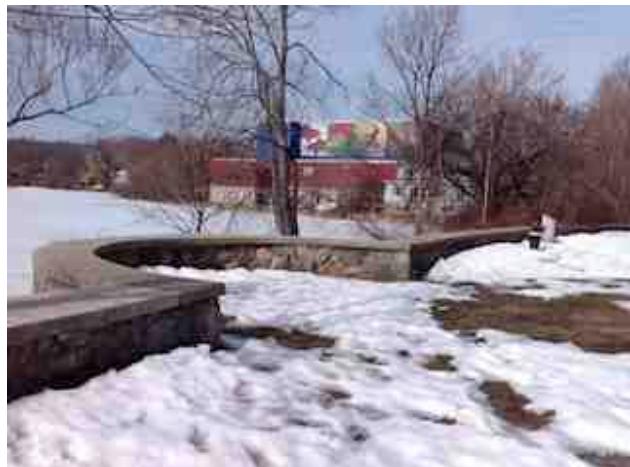
Photo 15

The Overlook area, dedicated in 1994, contains no accessible route to the public amenities in this area, including benches, signage, overlook bays, and memorial markers. (Photo 15)

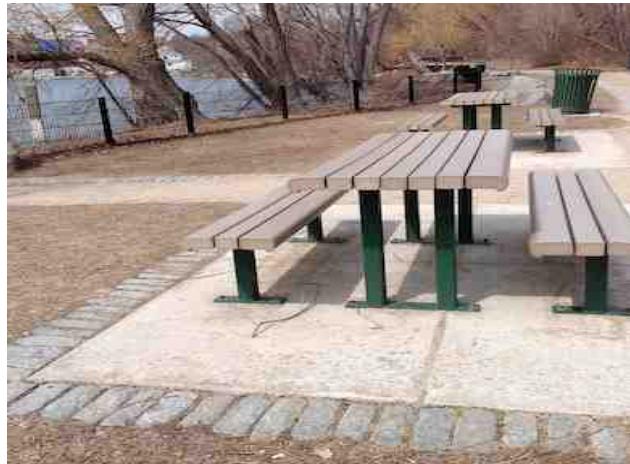
Photo 17

Picnic areas do not include accessible routes because the cobblestone edging is not smooth, level and slip-free. In addition, there needs to be a minimum four feet path to allow individuals using wheeled mobility devices to enter and circulate around the picnic table and bench amenities. (Photo 17)

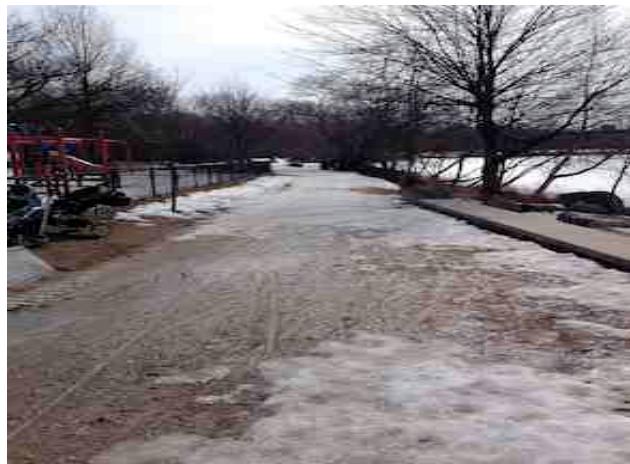
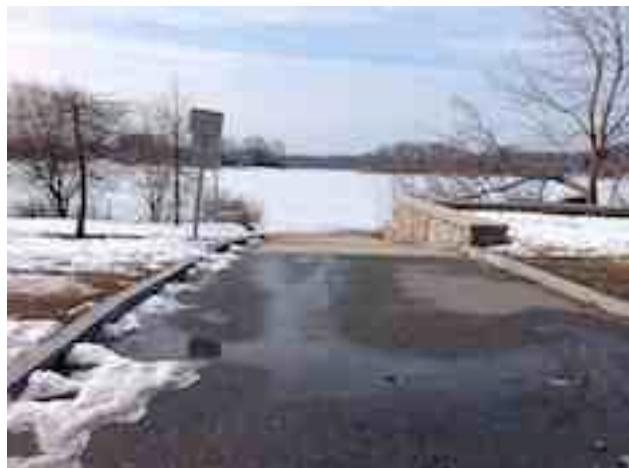
Photo 18

The shoreline path is well graded, clearly designated and includes ample passing space. Water accumulation, snow removal and ground surface displacement issues require regular and seasonal maintenance. (Photo 18)

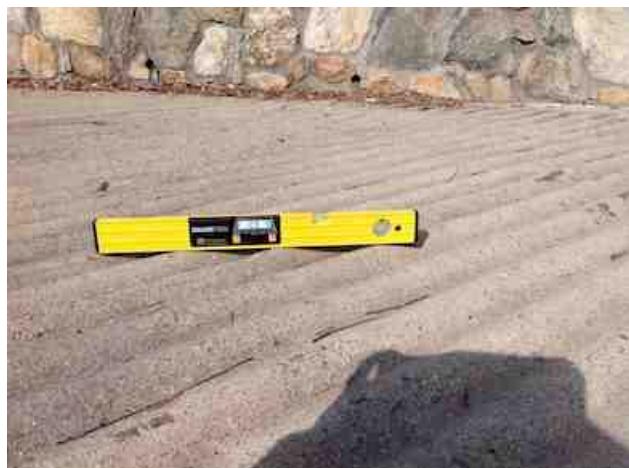
Photo 19

The construction of the Boat Ramp was completed without provision of an accessible route or inclusive adaptive sports programming. There is no provision of at least one 60-inch level boarding pier/launch dock for persons using mobility accessories to embark and disembark onto rowboats. There is no provision of a smooth walking surface. (Photo 19)
